APEX-509

# SUMMARY REPORT OF HTRE NO.3 NUCLEAR EXCURSION

**SUMMARY REPORT OF HTRE NO.3 NUCLEAR EXCURSION**

United States Air Force

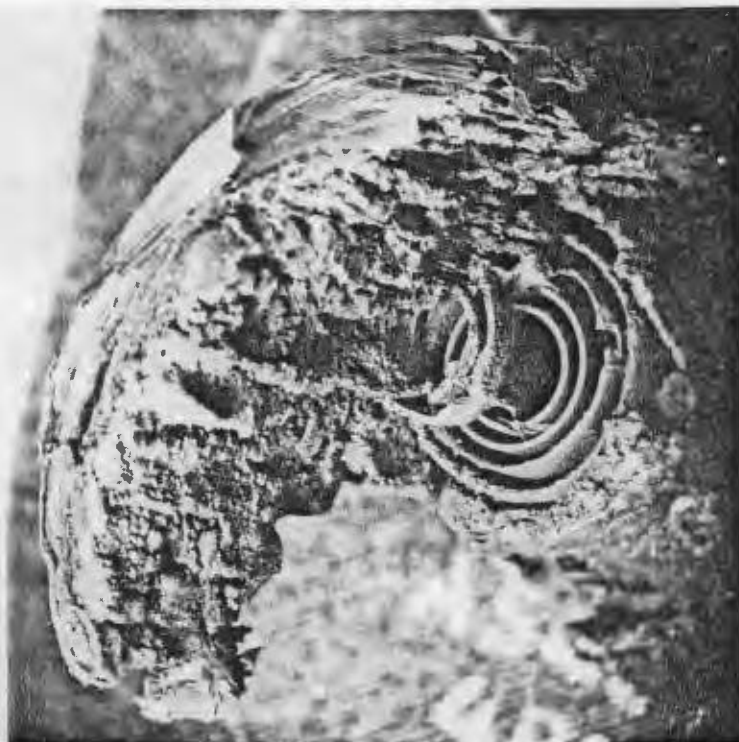
Fig. 78 - Meltdown and oxidation of stage 5, cartridge 1060, cell 273

This series of photographs shows that the greatest damage is in stages 4, 5, and 6. An explanation for this is that more chemical oxidation occurred in these stages than in stages 7 through 16. Chemical analysis of the molten material obtained from stages 4 and 5 verifies that chemical oxidation did occur in these stages. Figure 85 shows the downstream face of stage 3 and indicates some damage to this stage. Stage 4, shown in Figure 86, shows the meltdown of the outer ring and the 180-degree position (the lower side of the fuel cartridge when installed in the core). Another view of stage 4 at the 0-degree position is shown in Figure 87.

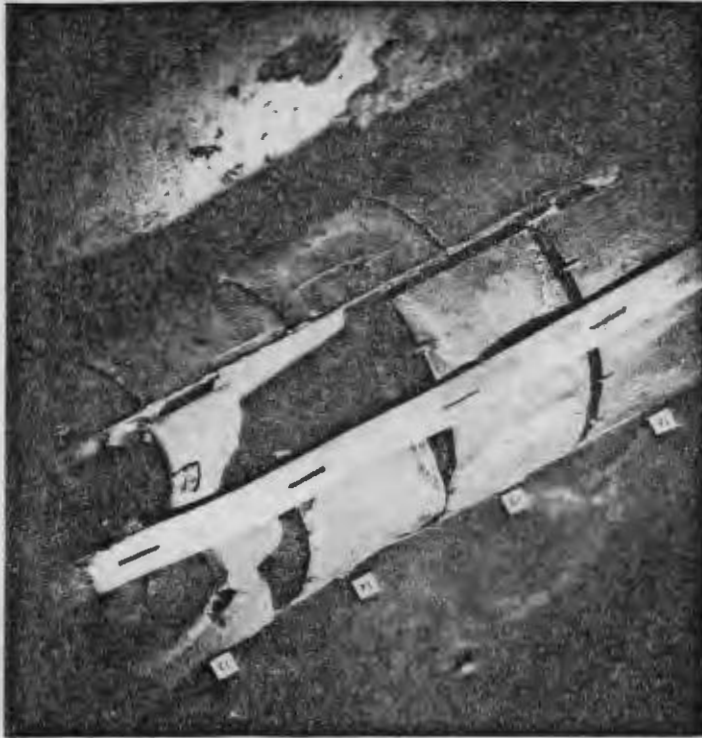
Fig. 80 - Damage to stages 10, 11, 12, and 13, cartridge 1060, cell 273

Inspection of the fuel cartridges that were removed from the moderator cells shows that melting and collapsing of the fuel elements was confined to stages 4 through 16. Fuel cartridge SN 1060 was removed from cell 273, which is in the outside circle of moderator cells. These cells produce about 7 percent less than the average total tube power and are representative of the lowest-power cells. The radial orientation (in degrees) indicated on the photographs is clockwise rotation from the "0" point (vertical centerline), looking downstream through the cartridge. Figure 76 shows the over-all fuel cartridge damage. The meltdown and chemical oxidation damage to stages 4, 5, and 6 of the fuel cartridge is clearly shown in Figure 77. The almost complete meltdown and oxidation of stage 5 is shown in Figure 78. Meltdown damage to stages 7, 8, and 9 is shown in Figure 79. Damage to stages 10 through 16 is shown in Figures 80 and 81. The meltdown

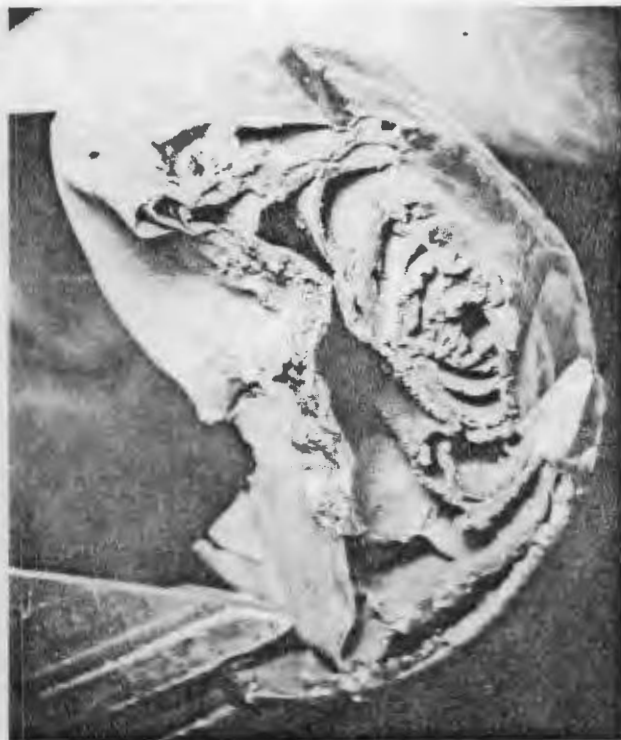
Fig. 82—Upstream face of stage 12, cartridge 1060, cell 273

of stage 12 is shown in Figure 82. The 19th stage, which did not reach a temperature level as high as stages 4 through 16, is shown in Figures 83 and 84 to have sustained relatively little damage.

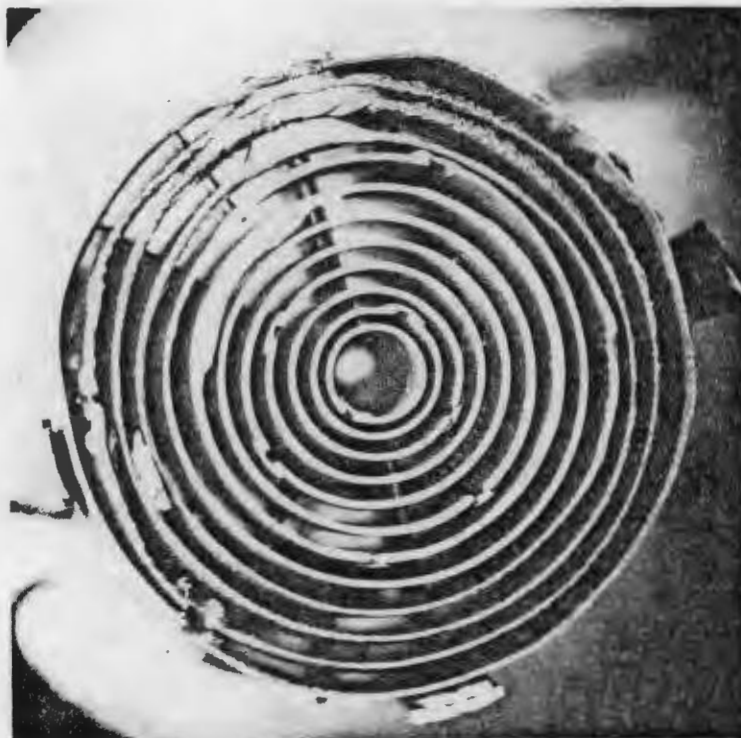
Fig. 85—Downstream face of stage 3, cartridge 1060, cell 273

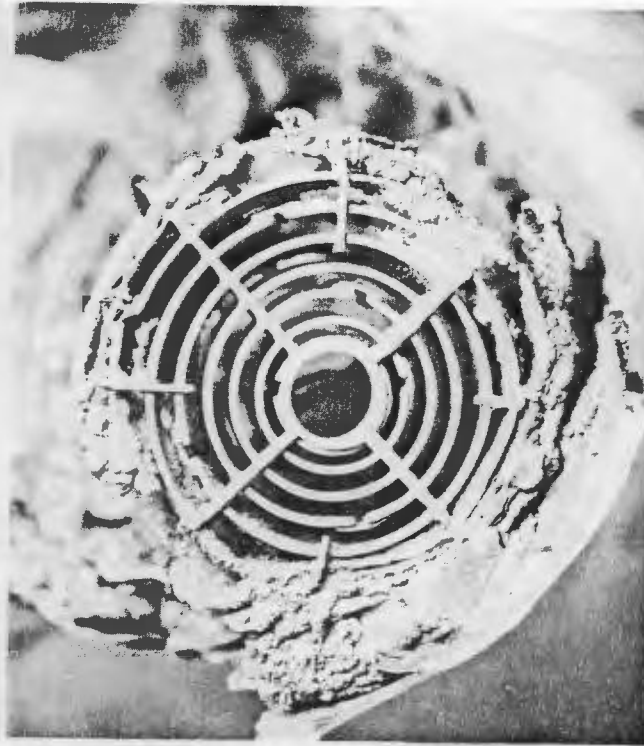
Fig. 86 - Upstream face of stage 4, cartridge 1060, cell 273

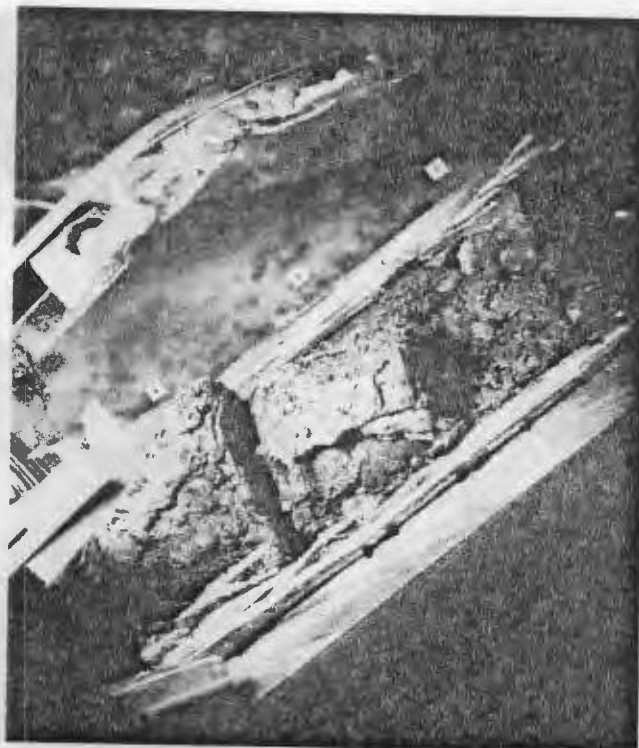
Fig. 90 - Stages 4, 5, and 6, cartridge 1129, cell 510

Another example of cartridge damage was obtained from cell 510, which is located in the innermost circle of moderator cells. These cells produce 7 percent above average total tube power and are representative of the highest-power cells. The total damage to this fuel cartridge is shown in Figure 88. Stages 1, 2, and 3, shown in Figure 89, appear to have sustained little or no damage. Figure 90 shows the meltdown and chemical oxidation damage in stages 4, 5, and 6. Figures 91, 92, and 93 show the damage that occurred to stages 7 through 15. The meltdown and possible chemical oxidation damage appear to be greater than the damage to the same stages in Cell 273 (Figures 79, 80, and 81). The damage sustained in stages 16 through 19 is shown in Figures 94 and 95.

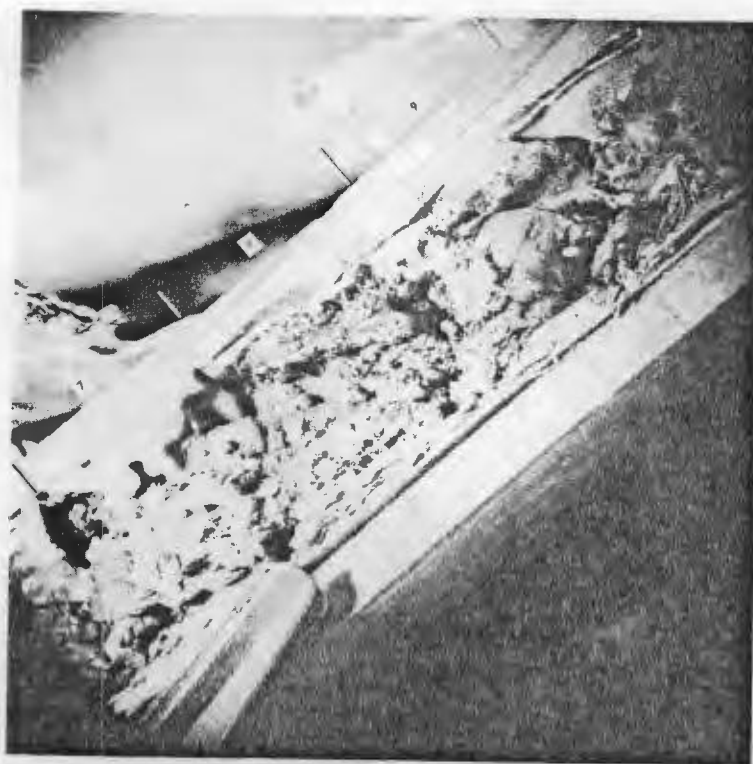
Fig. 91 - Stages 7, 8, and 9, cartridge 1129, cell 510

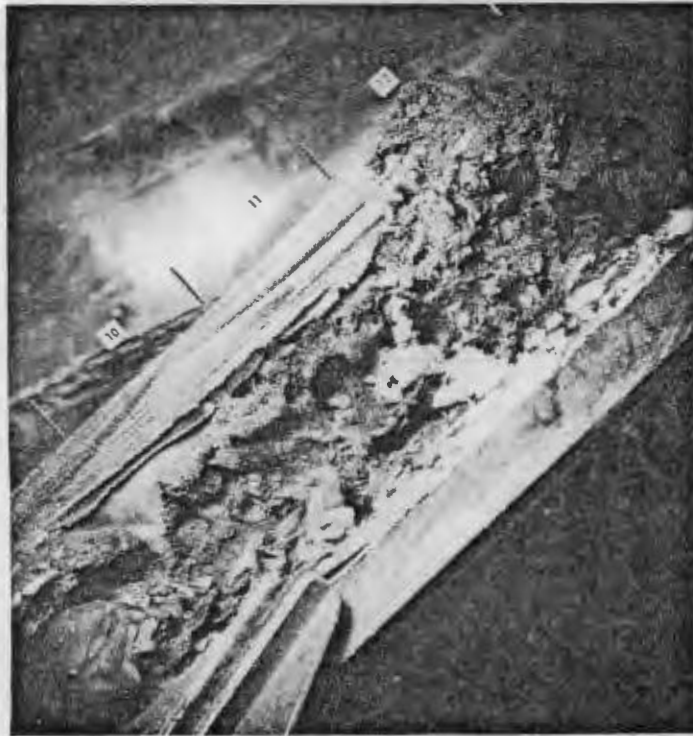
Fig. 92 - Stages 10, 11, and 12, cartridge 1129, cell 510

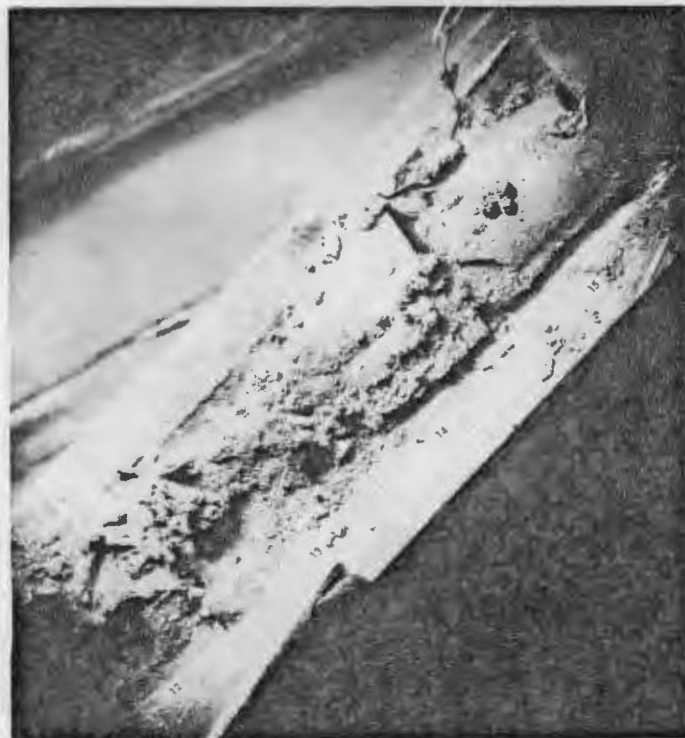
Fig. 93 - Stages 13, 14, and 15, cartridge 1129, cell 510

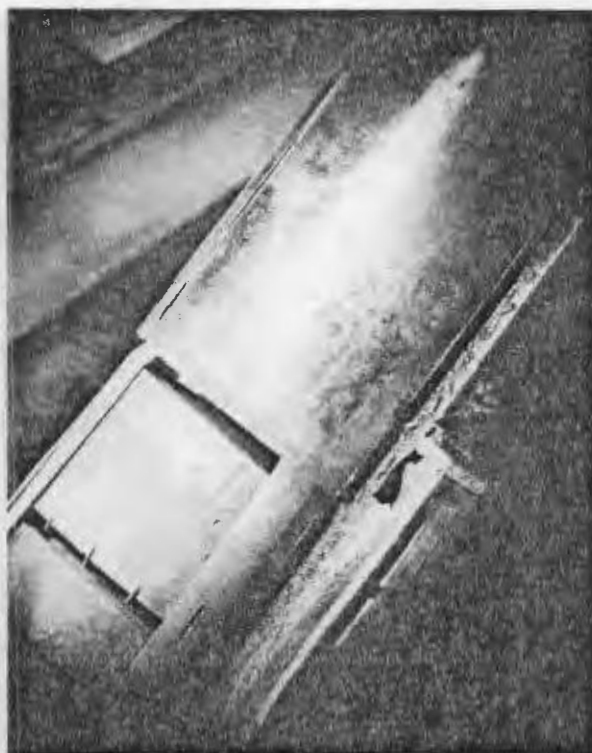
Fig. 95 - Stage 19 and tail cone, cartridge 1129, cell 510

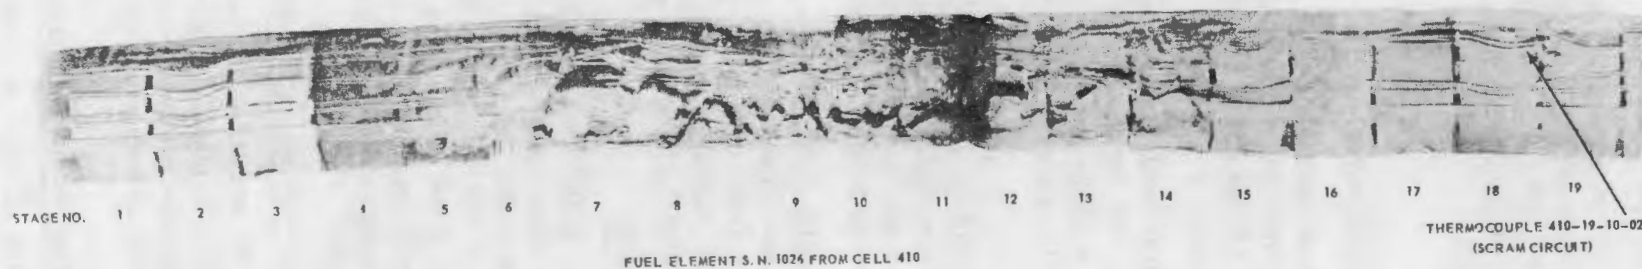
661-19-10-10  
THERMOCOUPLE

FUEL ELEMENT 1090 CELL 661 STAGE 19  
LOOKING THROUGH TAIL PIECE

Fig. 98 - Fuel cartridges from cells 410 and 661 showing fuel element thermocouples

some fuel element material at stage 10. The lead wire sheath for this 19th-stage thermocouple was also noted to be badly charred at the sixth, seventh, and eighth stages. The thermocouple lead bead and shield appeared to be in satisfactory condition (see cell 661-19th stage photograph in Figure 98).

The fuel cartridge in cell 410 sustained extreme melting at stages 9, 10, 11, and 19. This melting can be noted in Figure 98. The 19th-stage leading edge where the thermocouple lead wires entered the stage as well as the entire stage sustained a high degree of meltdown. Because of the meltdown damage the lead wire could not be traced along the entire length of the cartridge.

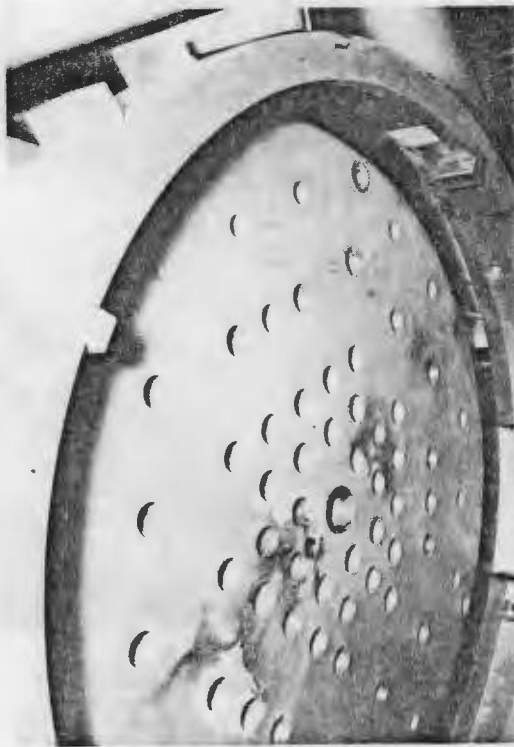
Fig. 107 - Aft face of front plug shield

No visible damage was sustained during the event by the front and rear plug shields, primary shield, combustor, and aft header. Figure 107 shows the aft face of the front

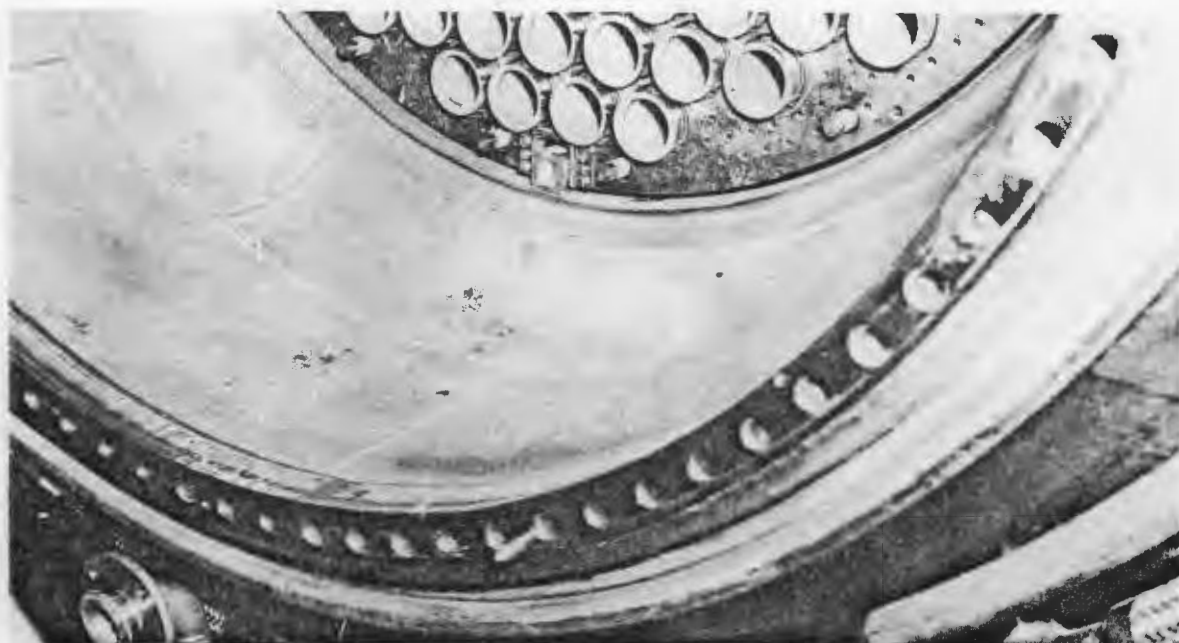
Fig. 109 - Deposits at bottom of primary shield

plug shield. Figure 108 shows the rear plug shield. Some foreign material was noted in the plenum aft of the core and can be noted in Figure 109. Figure 110 shows a view of the combustor. Figure 111 shows the aft header. The foreign material noted in the combustor and aft header was determined to be the remains of the aft-plug shielding measurement devices; that is, copper foils, aluminum and cadmium cover, and sulfur pills. One section of insulation material in the rear-plug shield will be replaced because of damage caused by the melted aft-plug measurement devices.
